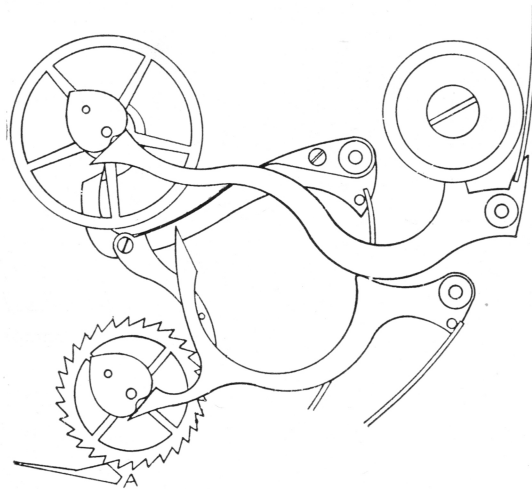
Figure 198—The minute register click A is improperly adjusted, causing the hand to make a sudden jump when the cam is released.

A similar jumping of the minute register hand may be caused by an improperly fitted star wheel click. Referring to Figure 198 it may be seen that the moment the minute register hammer releases the cam, the click will
